Contract #: 04-0120F4Cty: SF/ALA Rte: 80 PM: 13.2/13.9File #: 99.28**WELDING INSPECTION REPORT****Resident Engineer:** Casey, William**Address:** 333 Burma Road**City:** Oakland, CA 94607**Report No:** WIR-027234**Date Inspected:** 24-Feb-2012**Project Name:** SAS Superstructure**OSM Arrival Time:** 700**Prime Contractor:** American Bridge/Fluor Enterprises, a JV**OSM Departure Time:** 1530**Contractor:** L & M Industrial Fabrication**Location:** Tangent, Oregon**CWI Name:** Tom Dreyer**CWI Present:** Yes No**Inspected CWI report:** Yes No N/A**Rod Oven in Use:** Yes No N/A**Electrode to specification:** Yes No N/A**Weld Procedures Followed:** Yes No N/A**Qualified Welders:** Yes No N/A**Verified Joint Fit-up:** Yes No N/A**Approved Drawings:** Yes No N/A**Approved WPS:** Yes No N/A**Delayed / Cancelled:** Yes No N/A**Bridge No:** 34-0006**Component:** Tower Chimney Parapet**Summary of Items Observed:**

CCO: 196 - Description: Construct parapet walls at the Tower Heads

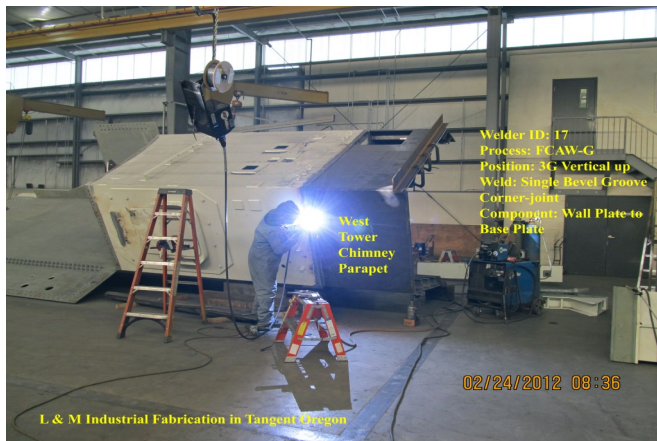
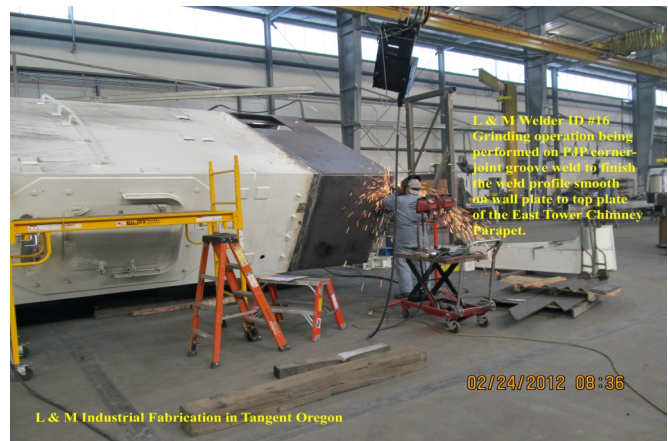
East Tower Chimney Parapet:

This QA Inspector randomly observed L & M welder Bradford Schroyer (Welder ID #16) performing the complete-joint-penetration (CJP) corner-joint groove weld operation per the Flux Cored Arc Welding (FCAW-G) gas shielding process in the (3G) vertical position connecting wall plate- (A12b) to base plate- (A12a) of the East Tower Head Chimney parapet wall. This QA Inspector observed QC Inspector Tom Dreyer verify prior to the start of the CJP corner-joint groove weld operation, that the minimum preheat temperature as per the approved WPS was established and afterwards; verified that the welding parameters (Amps, Volts and Travel Speed) were in accordance with WPS-D1.5-FC-TC-U4b-GF-3G using Hobart Excel Arc E71T-1 (.052") diameter electrode.

The welding operation was in-process at this location and the workmanship on this date appeared to be in general compliance with the contract specifications.
